Procedia Engineering 161 (2016) 729 – 737

World Multidisciplinary Civil Engineering-Architecture-Urban Planning Symposium 2016,  
WMCAUS 2016

## Behavior of Historic Buildings in Zones with Moderate Seismic Activity. Case Study: Banat Region, Romania

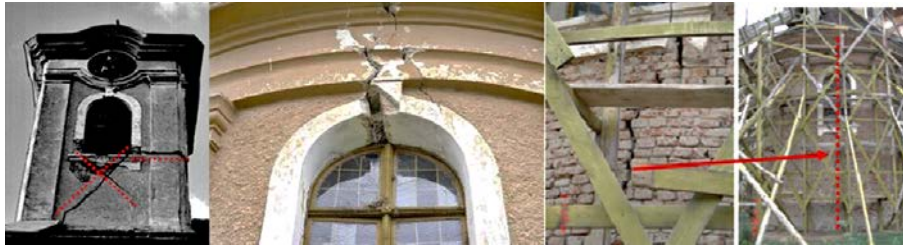
Fig. 6. Cracks in the tower, western wall and eastern wall.

In the Banat seismic zone there are historic buildings of 3 religious denominations: orthodox, catholic and Jewish. As a result of several earthquakes, no failures of any places of worship from these denominations were recorded. The orthodox and catholic churches were built in Romanesque style. The main difference is that orthodox churches present towers and pendants, and also in some synagogues are present pendants. Generally, orthodox churches record damages in the tower and apse area. In Fig. 5 and Fig.6 there are presented these damages for a Serbian orthodox church from Birda village, Timis County, at approximately 15 km from the epicenter of the 1991 earthquake.

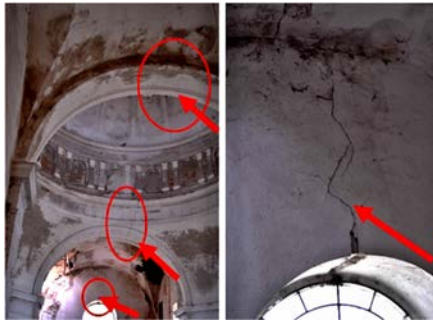
Fig. 8. Catholic Church from Bobda – cracks in the nave and narthex area.

In Fig. 8 and Fig. 9 there are presented cracks which appeared in the Catholic Church from Bobda village, Timis County, and in the Synagogue from the Citadel from Timisoara [11]. In order to reduce the mass and improve the seismic behavior of the cupolas, the builders renounced using brick masonry for these historic structures in favor of superb riveted steel structures.

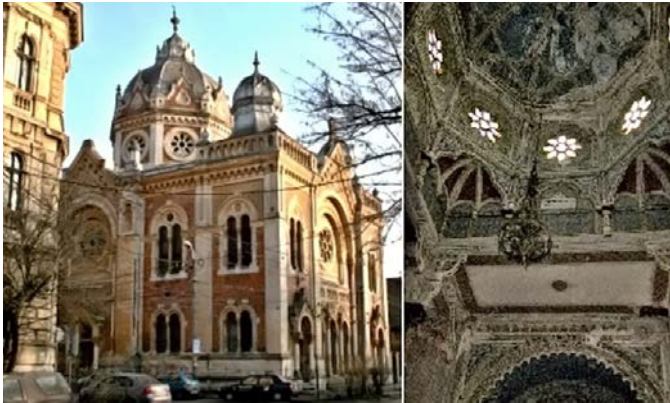
Fig. 11. Synagogue from Traian Square from Timisoara – steel cupola.

In Fig. 10 there is presented the steel cupola from the Catholic Church from Bobda [12] village and in Fig. 11 the cupola from the synagogue from Traian Square in Timisoara. Unfortunately, lacking specific design recommendations for zones with low seismic activity, the cupola of the Synagogue from the citadel was irreversibly consolidated by casting a layer of concrete over its entire surface in the 1960's, as it can be observed in Fig. 12.

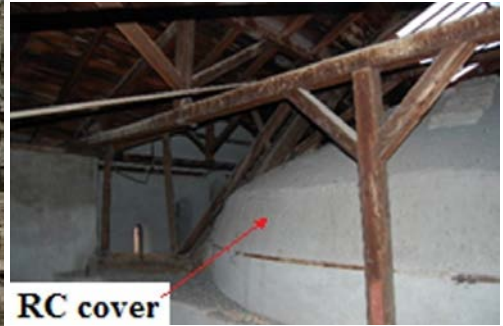
Fig. 12. Reinforced concrete casted over the cupola from the Synagogue from the Citadel from Timisoara.

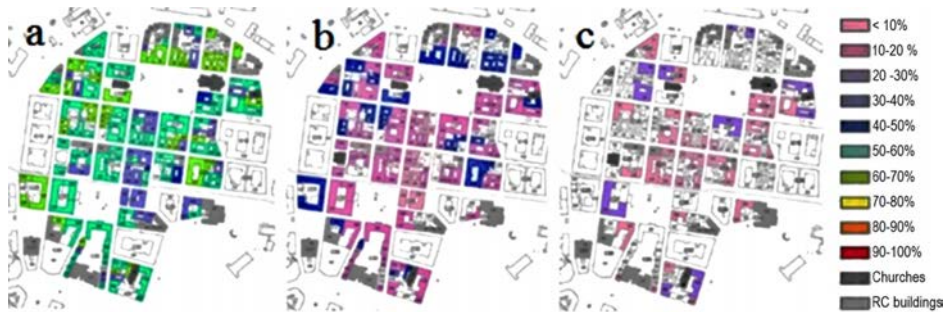
Fig. 13. Vulnerability assessment of masonry buildings from Timisoara for (a) simple overturning failure, (b) vertical bending failure, (c) in plane failure [15-16].

Vulnerability maps were defined, indicating a small number of historic buildings which are vulnerable to in plane and out of plane failures [15,16], as it can be seen in Fig. 12. These results show good correspondences with the real state of these buildings in the present time.
